Influence of proximal box elevation on the marginal quality and fracture behavior of root-filled molars restored with CAD/CAM ceramic or composite onlays

Journal Article

Ilgenstein, Irina; Zitzmann, Nicola U; Bühler, Julia; Wegehaupt, Florian J; Attin, Thomas; Weiger, Roland; Krastl, Gabriel (2015). Influence of proximal box elevation on the marginal quality and fracture behavior of root-filled molars restored with CAD/CAM ceramic or composite onlays. *Clinical Oral Investigations*, 19(5):1021-1028.

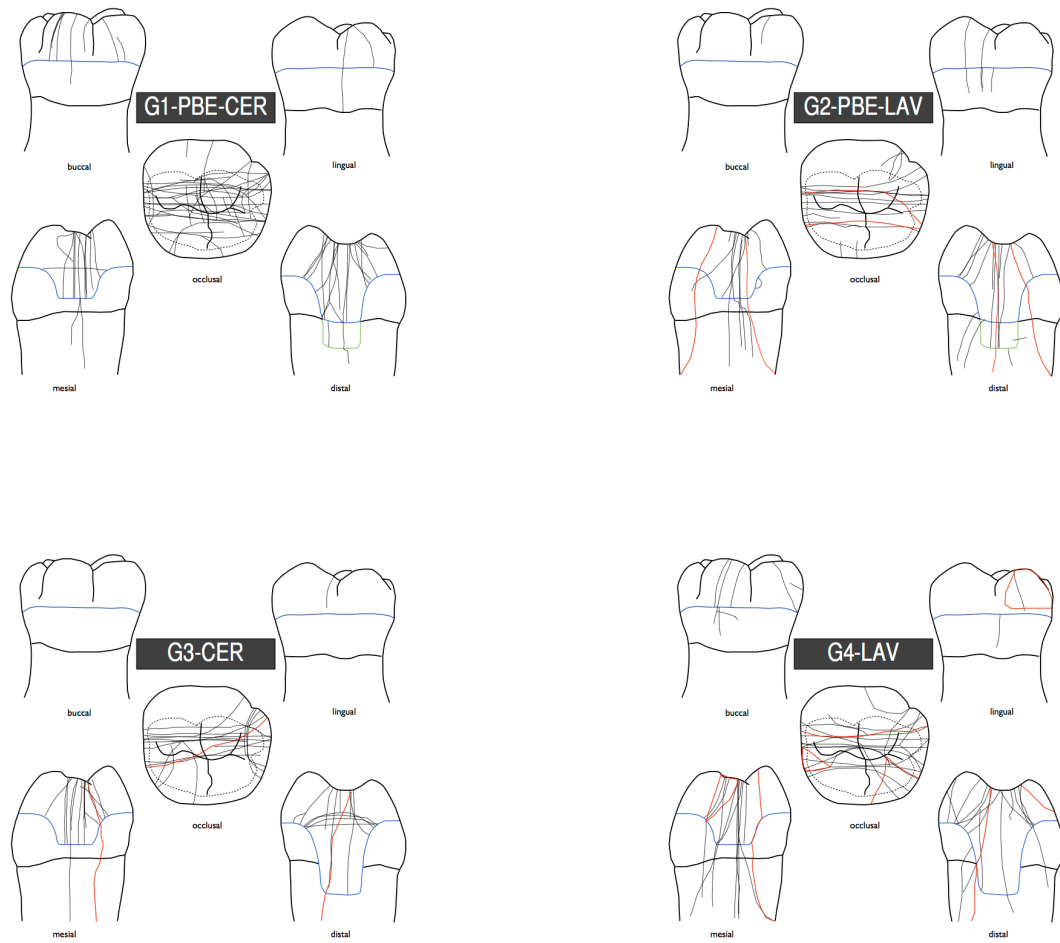
Fig. 4 Detailed failure modes of each experimental group, summarizing the main fractures (red lines) and cracks (black lines).

All specimens were meticulously examined under a stereomicroscope (Wild-Heerbrugg AG, Heerbrugg, Switzerland) at a magnification of x16 to obtain a detailed failure analysis. The fracture lines of each specimen were identified and categorized into three patterns: (1) fractures affecting solely the restoration, (2) fractures affecting both the restoration and the tooth above the simulated bone level, and (3) fractures affecting both the restoration and the tooth below the feigned bone level. The latter failure type was judged to be non-restorable, while categories 1 and 2 were deemed to be restorable fracture modes. Each specimen was investigated from five sides (buccal, lingual, mesial, distal, and occlusal), and any visible fracture line was illustrated on a schematic according to its direction and position.

Specimens restored with ceramic onlays (G1 and G3) predominantly exhibited fractures solely within the restoration, while in teeth restored with composite onlays (G2 and G4), the percentage of catastrophic failures increased. In groups G1, G2 (with PBE) and G4 (no PBE), all fractures on the distal aspect of the tooth had a vertical orientation, while in group G3, horizontal fractures of the ceramic restoration at the level of the cuspal reduction were observed in 4 out of 12 specimens (Table 3; Fig. 4).
